Cow Creek 2001 Stream Survey

The Santa Fe National Forest conducted stream surveys in the upper Cow Creek Watershed during the summer and fall of 2001. The streams included in the survey were Cow Creek, Elk Creek (tributary to Cow), and Sheep Creek (tributary to Elk). A total of 23.90 miles of stream were surveyed: 18.4 in Cow Creek, 4.0 in Elk Creek, and 1.5 in Sheep Creek. The results of the Elk and Sheep Creek stream surveys can be found in their respective stream inventory reports.

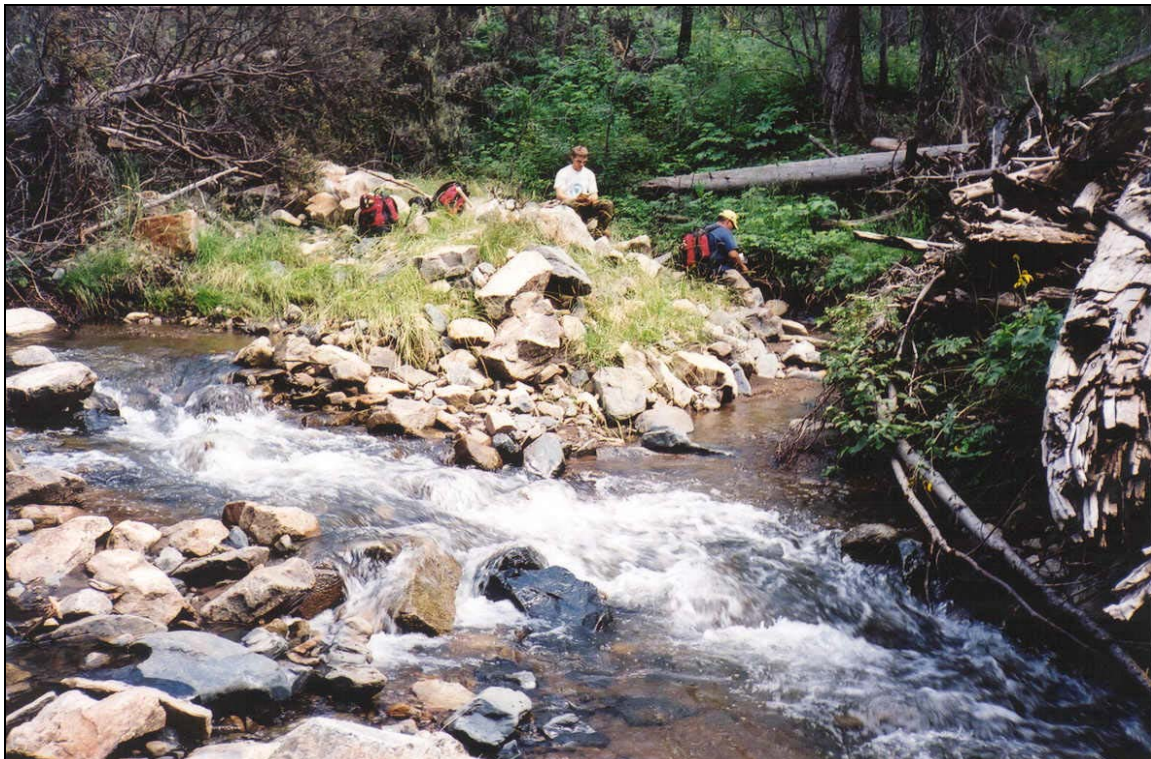
Photo 1. Reach 9, NSO168, T17. Stream survey crew obtaining the UTM coordinates for a tributary to Cow Creek with a Trimble GeoExplorer 3 GPS unit (21 Aug 2001).

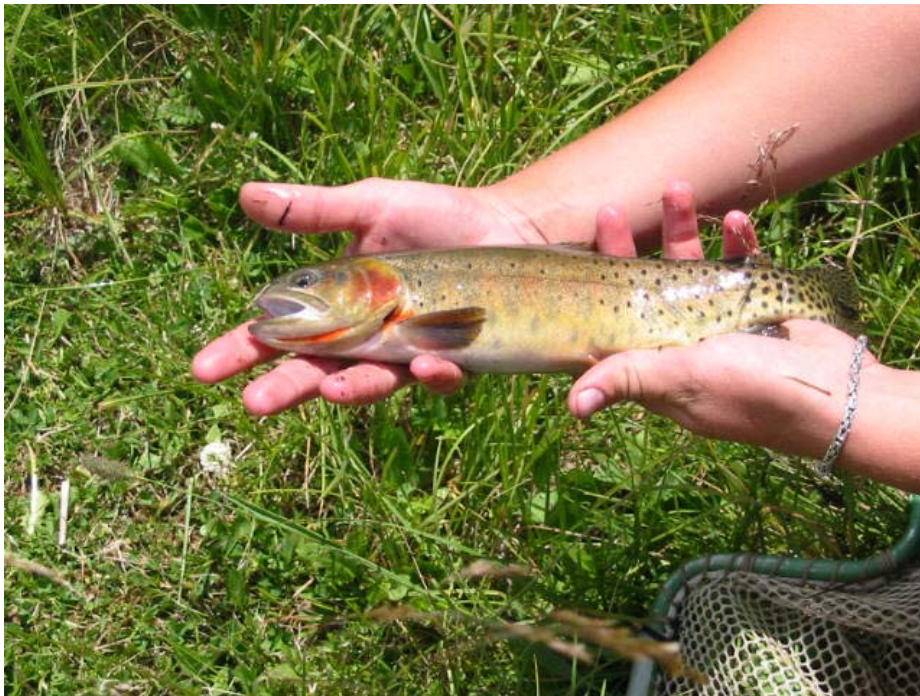
Photo 8. Rio Grande cutthroat trout captured in Reach 11 of Cow Creek during a backpack electrofishing spot survey (26 Jul 2002).

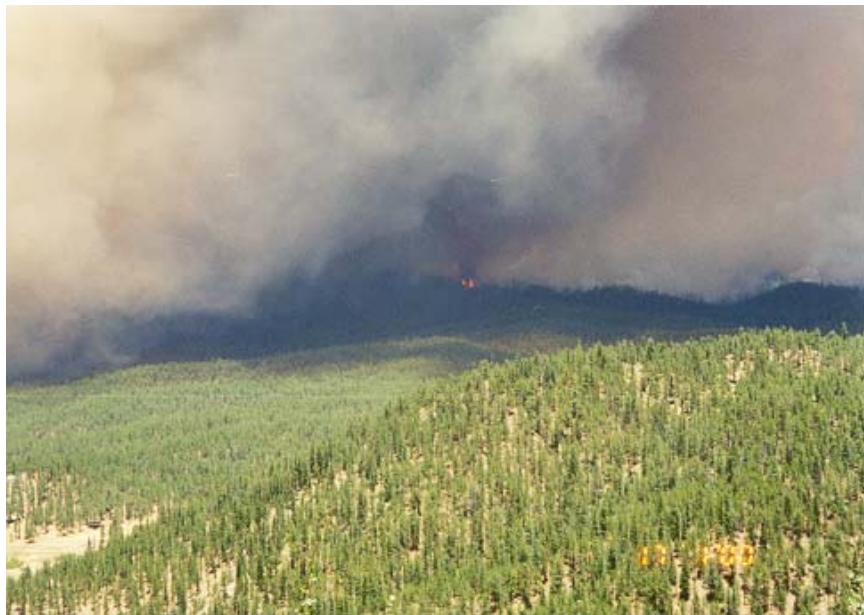
Photo 13. The Viveash Fire on May 30th, 2000. The fire consumed 20,000 acres that day.

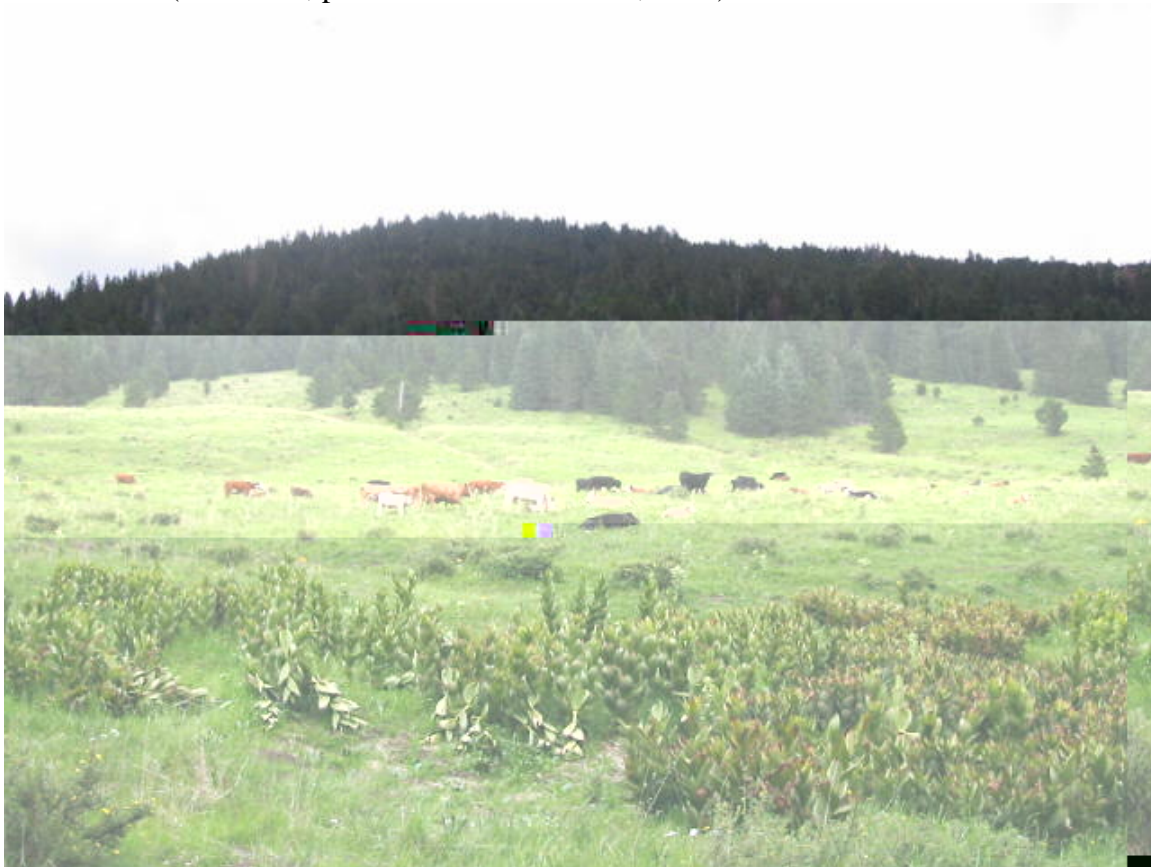
Photo 15. Grazing in the upper Cow Creek Watershed.

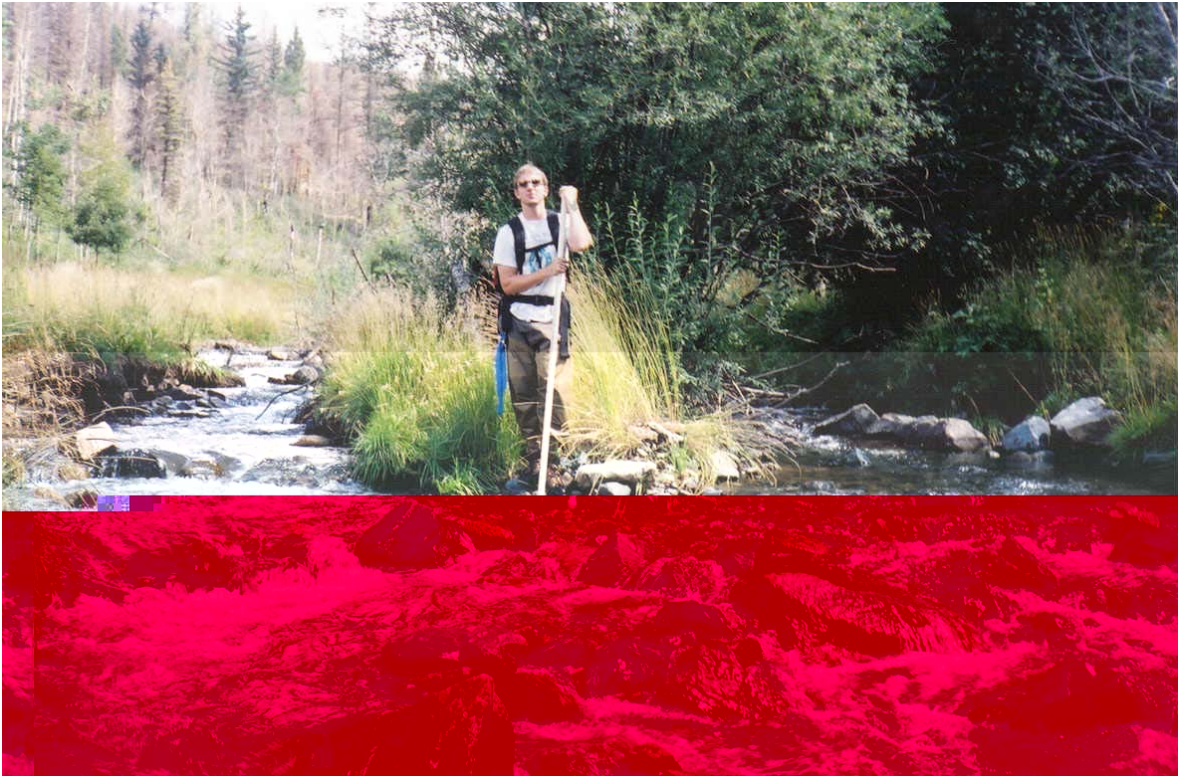
Photo 16. Reach 9, NSO 186, R76. Breaking an NSO at a side channel (22 Aug 2001).

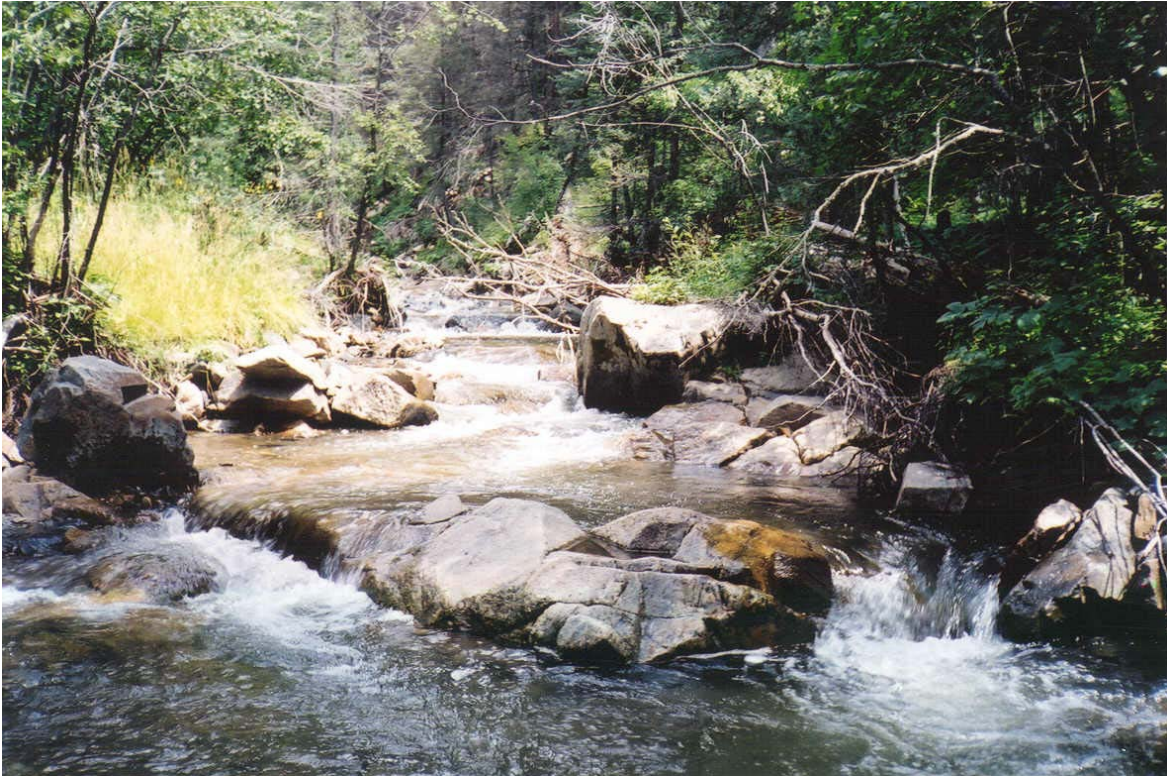
Photo 21. Reach 9, NSO 198, P69. Typical cascade habitat (22 Aug 2001).

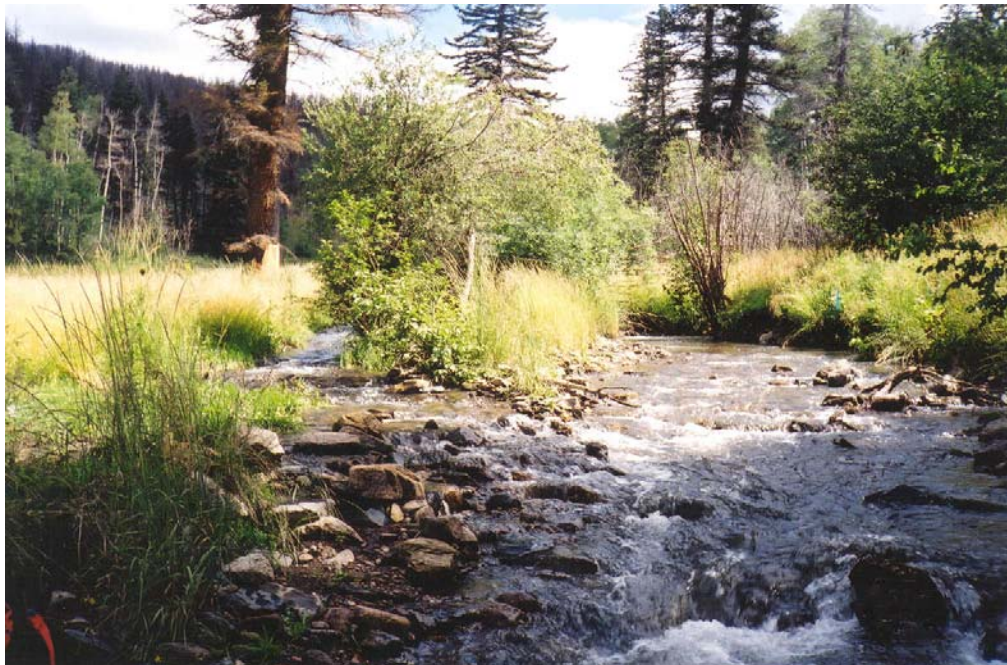
Reach 9 was **not properly functioning** for large woody debris, having only 9.3 pieces of LWD per mile (20 total in the reach). In order to be properly functioning, greater than 30 pieces of LWD per mile are required. Although low, LWD is dramatically higher than in previous reaches. Reach 9 is much more heavily forested than previous reaches, and should show a tremendous increase in LWD in coming seasons due to disturbance caused by the Viveash Fire.

Photo 22. Reach 9, NSO183, R75. Riffle with side channel. Note the amount of standing wood in the background (22 Aug 2001).

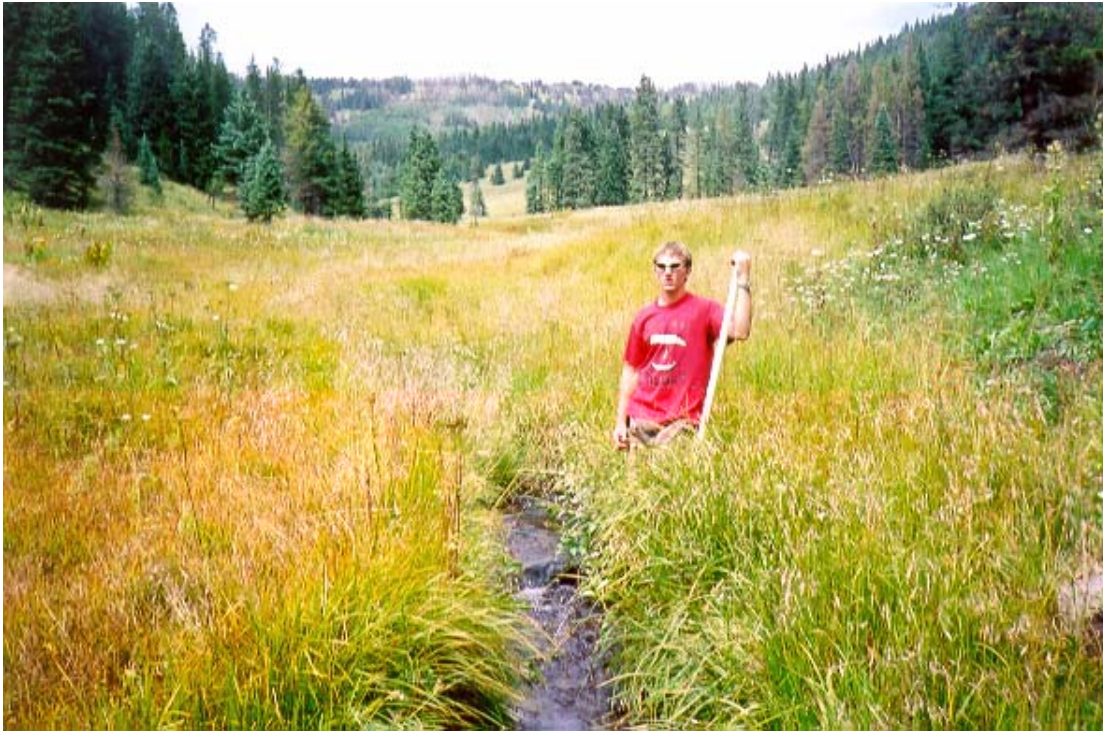
Reach 11 consists largely of an open meadow system. Banks within the reach were well covered by equisetum and grasses. Some conifers occur along streambanks as well. In the lower end of the reach, sporadic speckled alder were observed.

Photo 24. Reach 11, NS0310, R133. Meadow near the headwaters of Cow Creek. Note: Grass height. (30 Aug 2001).

- Reach 11: In Reach 11, as in Reach 10, RGCT distribution needs to be more thoroughly examined. The upper limit of RGCT range needs to be determined and, if possible, what limiting factor is keeping RGCT out of the upper end of the reach. In addition, cattle presence and the impacts on the stream channel need to be monitored in greater detail.
